Geologic Assessment

Regulated Entity Name: NBU Property Expansion

GEOLOGIC ASSESSMENT TABLE						PROJECT NAME: NBU Property Expansion - New Braunfels, Comal County, Texas (RKI Project No. ASF19-092-00)													
LOCATION			FEATURE CHARACTERISTICS											EVALUATION			PHYSICAL SETTING		
1A	1B *	1C*	2A	2B	3	4			5	5A	6	7	8A	8B	9	10	11		12
FEATURE ID	LATITUDE	LONGITUDE	FEATURE TYPE	POINTS	FORMATION	DIMENSIONS (FEET)			TREND (DEGREES)	DOM	DENSITY (NO/FT)	APERTURE (FEET)	INFILL	RELATIVE INFILTRATION RATE	TOTAL	SENSITIVITY	CATCHMENT AREA (ACRES)		TOPOGRAPHY
						X	Y	Z									<40	>40	
S-1	N29 42 19.8	W98 10 14.2	C	30	Kep	62.0	22.5	10.0	225° (NE-SW)	10			N, FS	35	75		✓	✓	Hilltop
S-2	N29 42 21.5	W98 10 19.3	C (Coreth Cave)	30	Kep	230.0	130.0	69.0	240° (NE-SW)	10			N, FS, X	35	75		✓	✓	Hilltop
S-3	N29 42 22.5	W98 10 21.5	SC	20	Kep	7.0	6.0	2.5	210° (NE-SW)	10			O, F	9	39	✓		✓	Hilltop
S-4	N29 42 22.3	W98 10 21.0	CD	5	Kep	8.0	5.0	2.5					F	6	11	✓		✓	Hilltop
S-5	N29 42 18.4	W98 10 30.4	CD	5	Kep	6.0	4.0	2.0					F	6	11	✓		✓	Hilltop

SITE GEOLOGY NARRATIVE
NBU Property Expansion
New Braunfels, Comal County, Texas

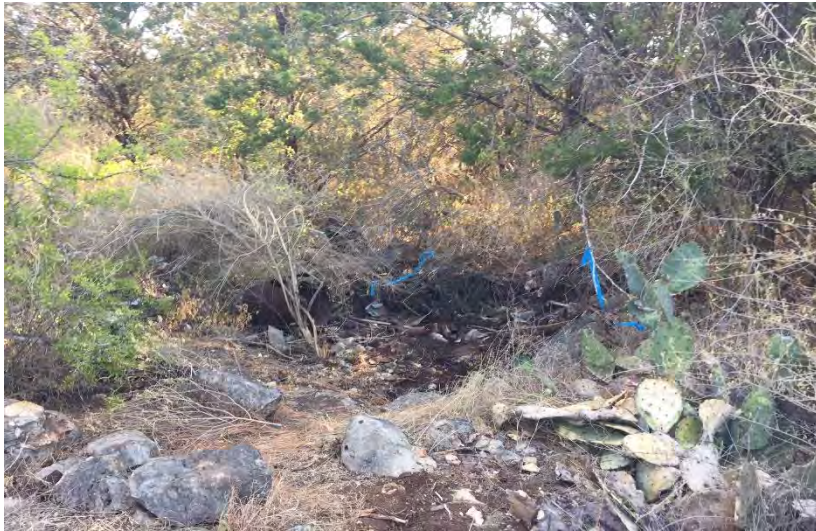
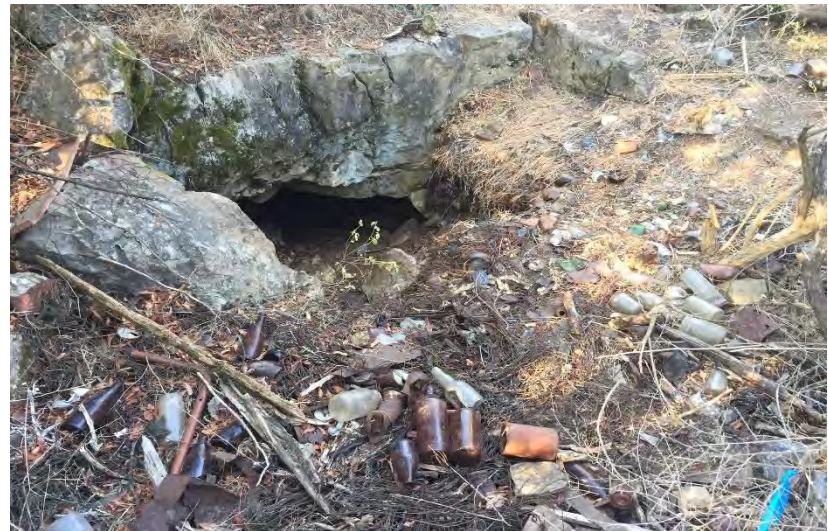
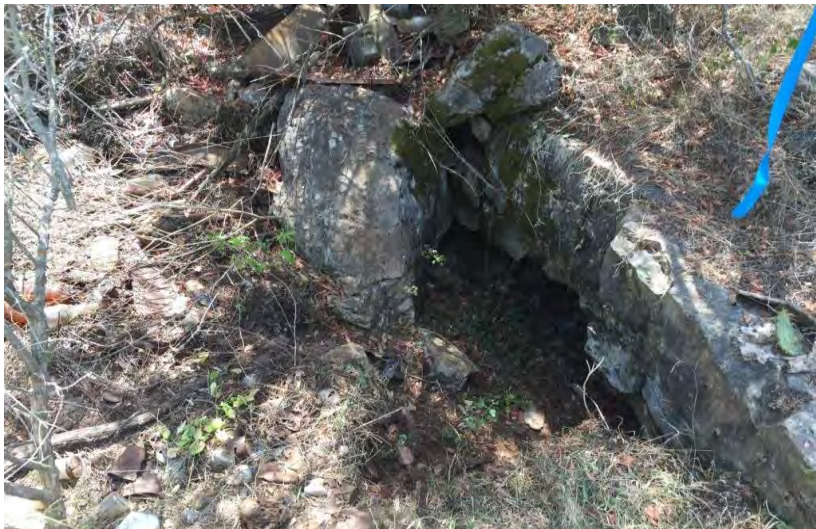
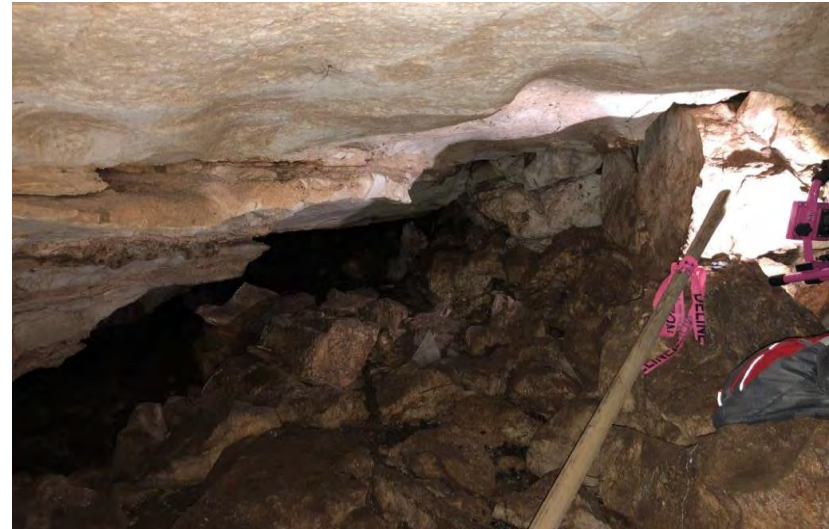
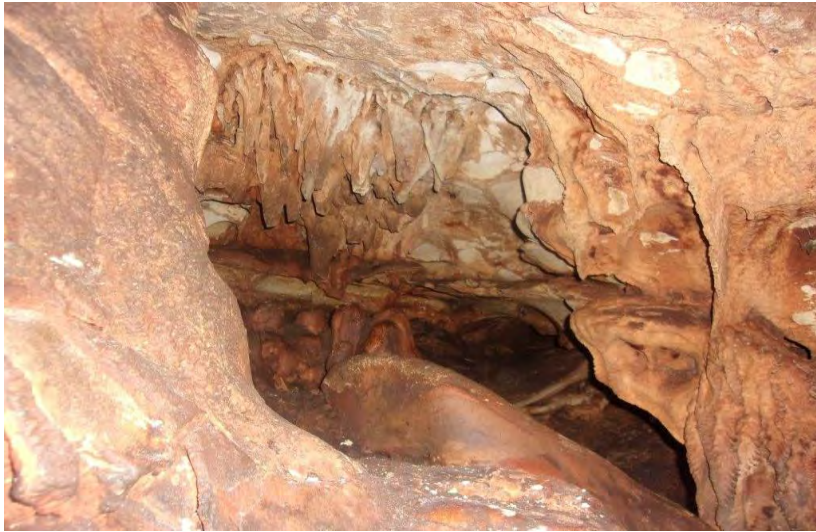
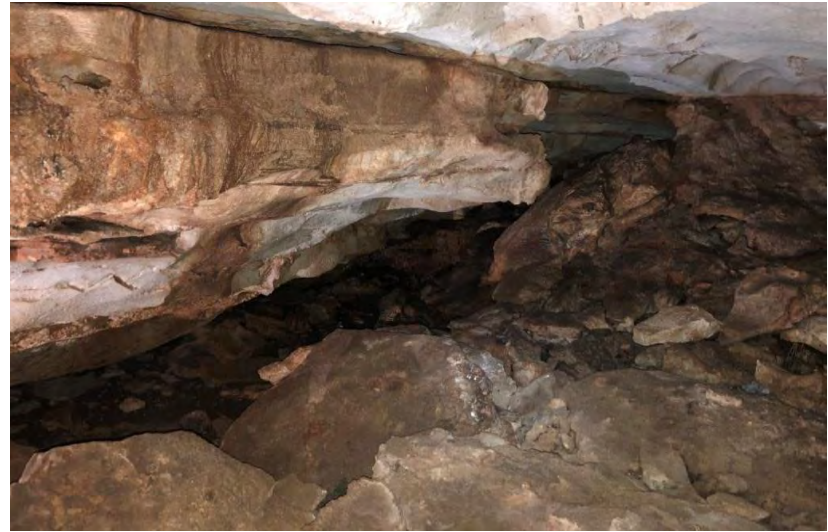
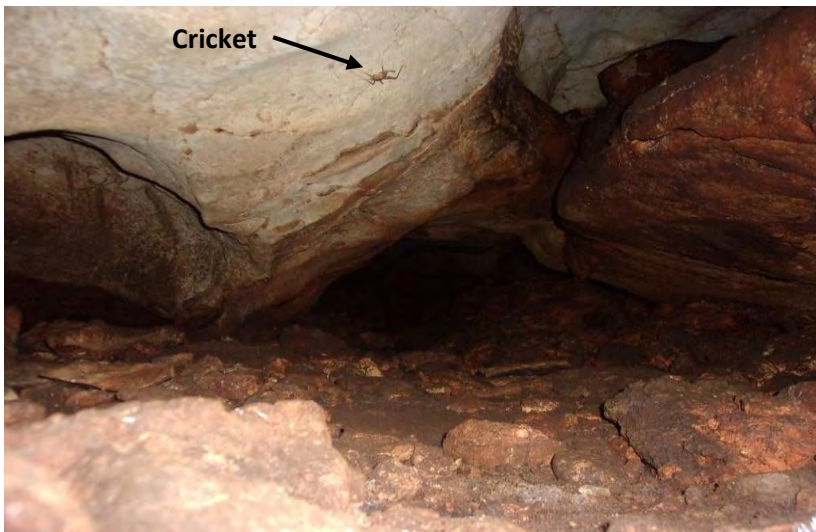
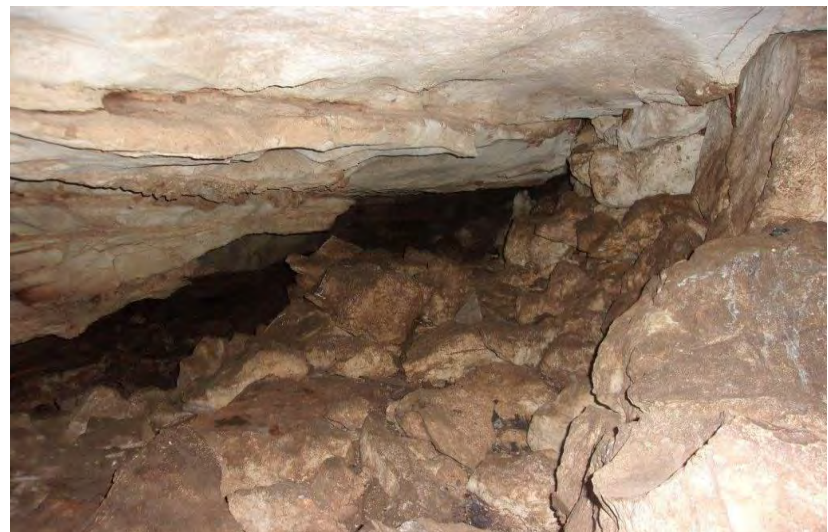
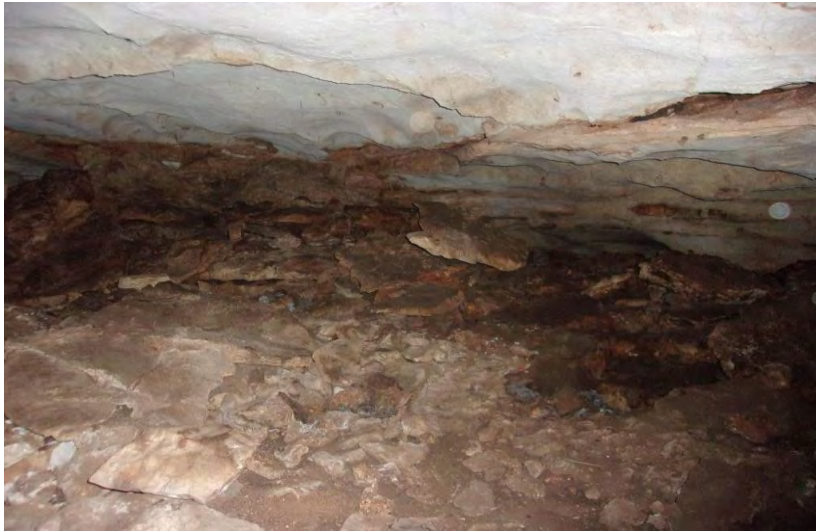
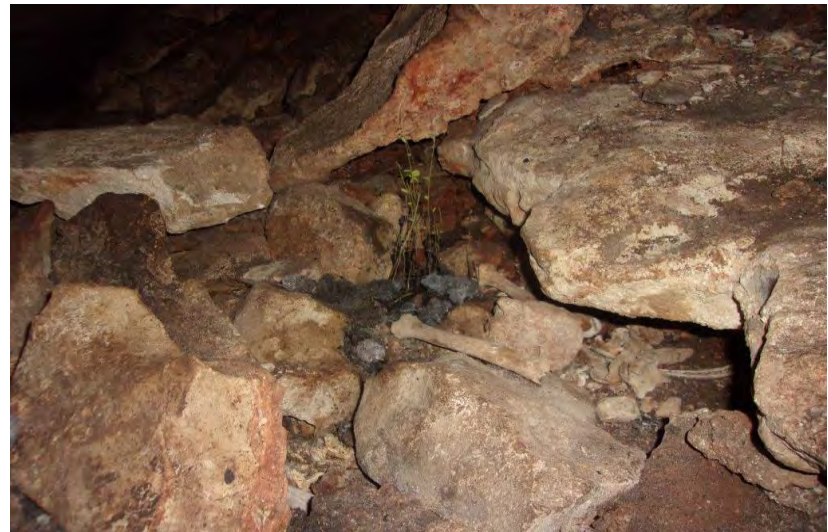
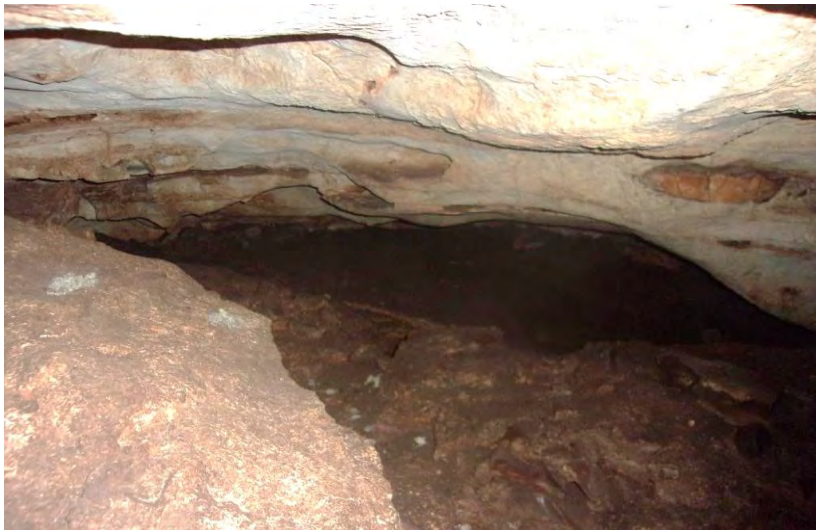
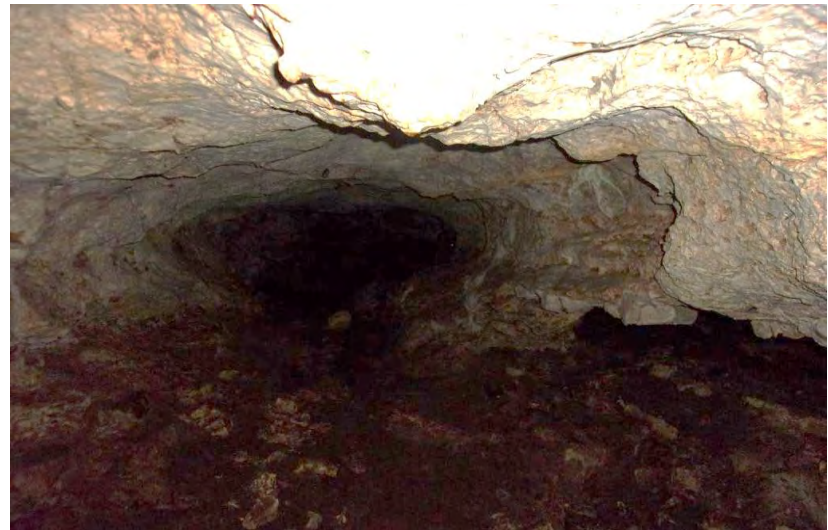
Feature S-1 consists of a sinkhole with associated cave development that collectively measures approximately 62 x 22 feet in plan view and has been exploited historically in association with past farm/ranch operations as a trash disposal site. The cave entrance and surrounding sinkhole depression were observed to contain ranch wastes and household rubbish consisting of tin cans, glass bottles, bailing wire, and automotive parts in addition to other minor debris. The cave entrance measures approximately 7.5 x 2.5 feet in length and width and opens to a small room. The cave is formed in the upper part of the Person Limestone and is inferred to extend approximately 10 feet below ground surface at its greatest depth.

No well-defined surface drainage features are associated with the cave. The cave is oriented along the dominant NE-SW structural trend although no well-defined fractures were observed within the cave. The cave was accessed by our field crew such that its maximum lateral extent could be determined. Observations within the cave confirmed slight air flow and the presence of normal cave fauna including spiders and crickets. The cave also appears to periodically host small animals including snakes, skunks, and porcupines. A plan view sketch of the cave is provided on the attached *Site Geologic Map*. Refer to photographs 1 through 12 in the attached *Feature Photograph Log*.

This feature is classified as sensitive owing to rapid infiltration potential.

Feature S-1 consists of a sinkhole with associated cave development that collectively measures approximately 62 x 22 feet in plan view. The cave entrance and surrounding sinkhole depression were observed to contain ranch wastes and household rubbish consisting of tin cans, glass bottles, bailing wire, and automotive parts in addition to other minor debris. The cave entrance measures approximately 7.5 x 2.5 feet in length and width and opens to a small room. The cave is formed in the upper part of the Person Limestone and is inferred to extend approximately 10 feet below ground surface at its greatest depth.

The cave was accessed by our field crew such that its maximum lateral extent could be determined. Observations within the cave confirmed slight air flow and the presence of normal cave fauna including spiders and crickets. The cave also appears to periodically host small animals including snakes, skunks, and porcupines.

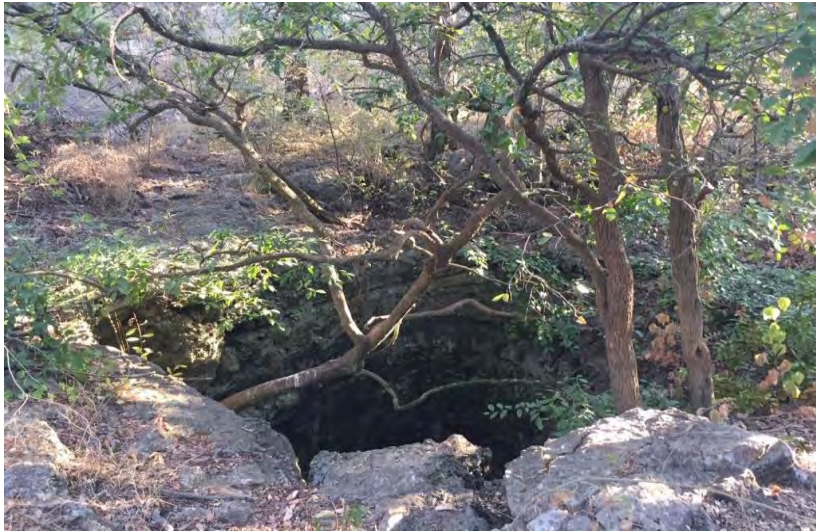
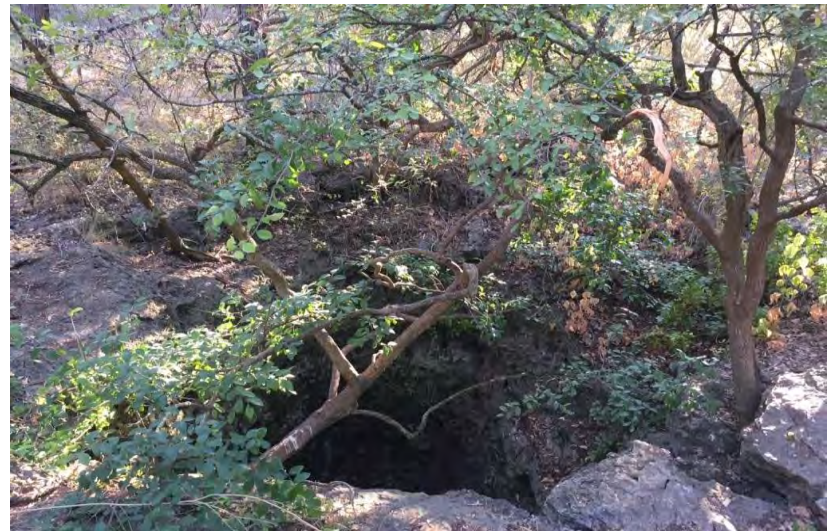
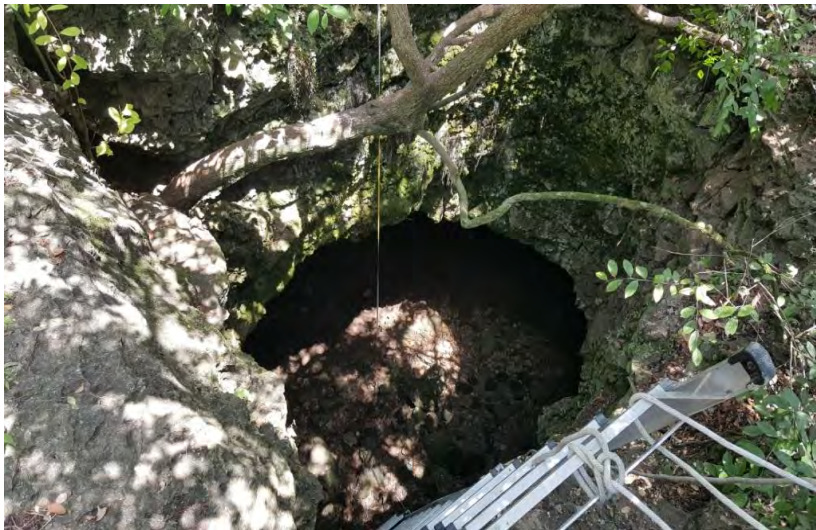
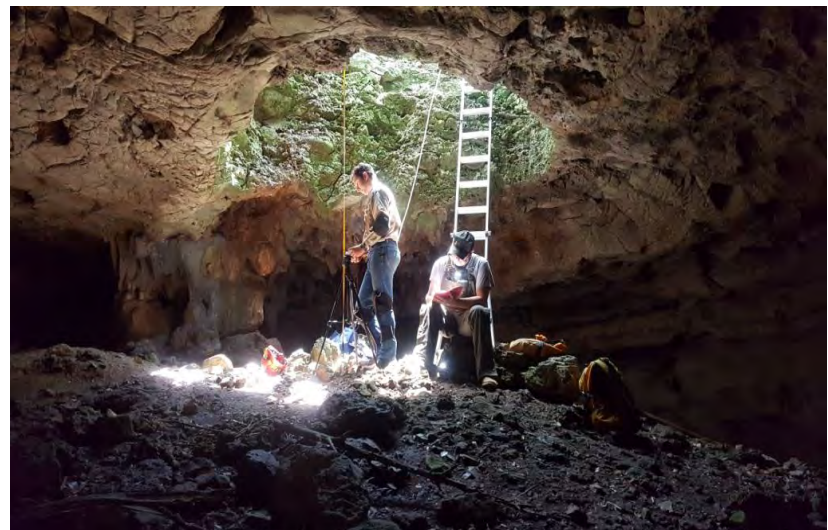
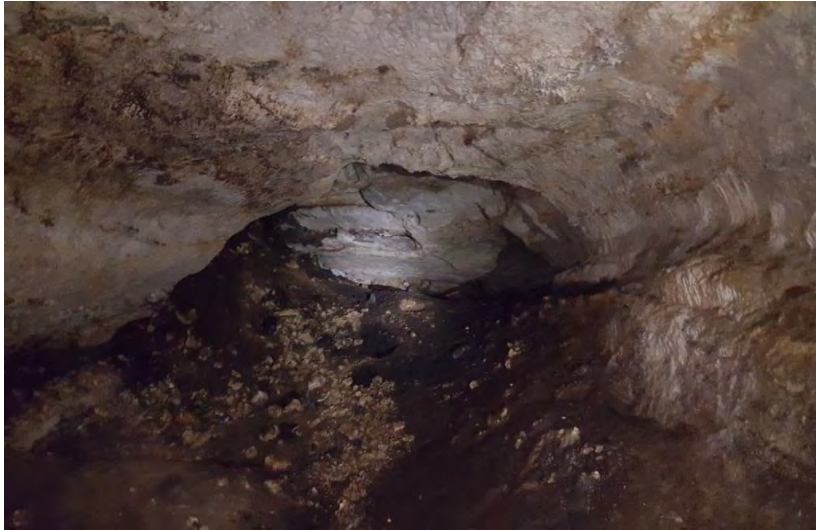
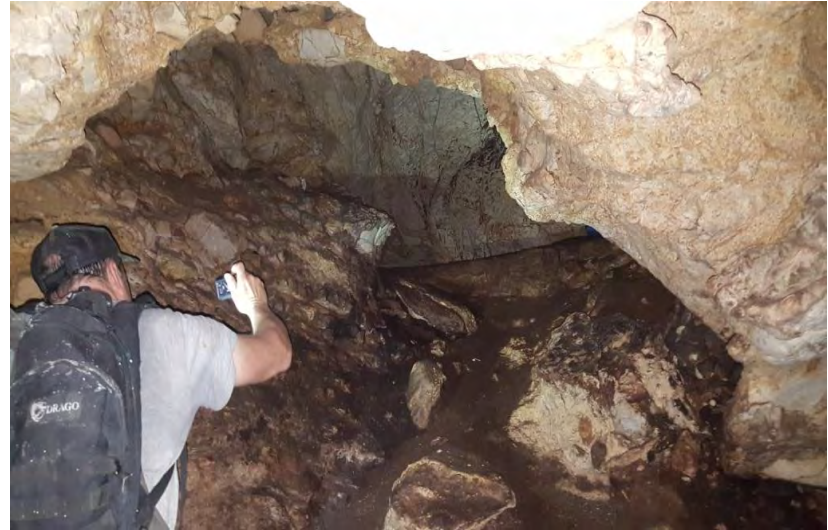
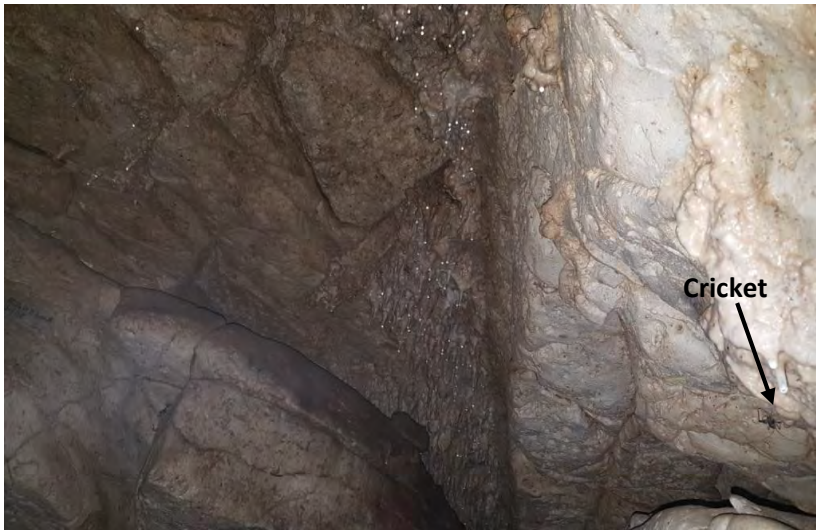
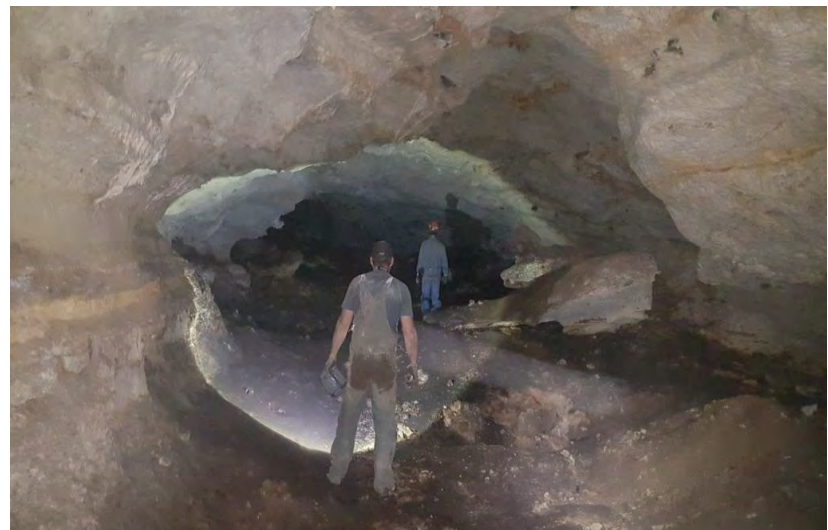
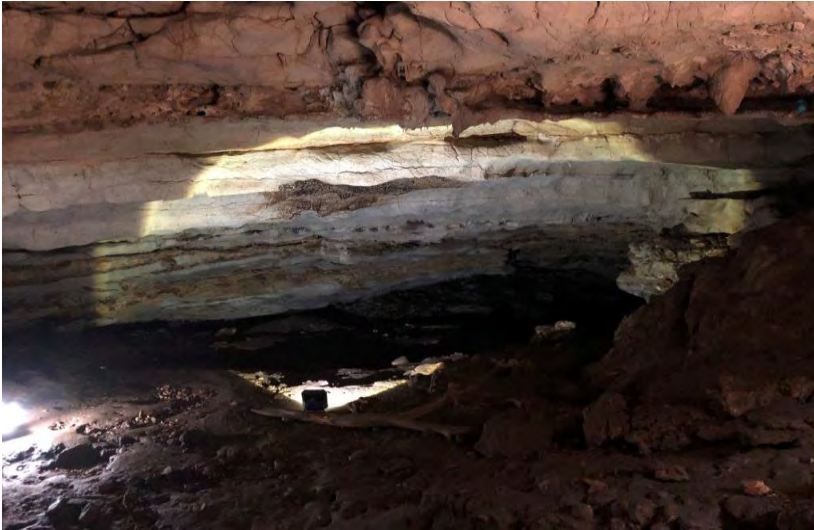
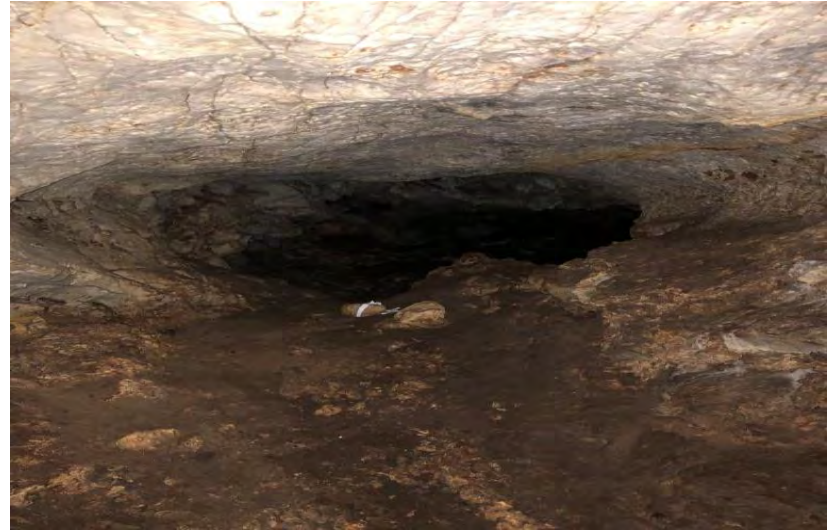
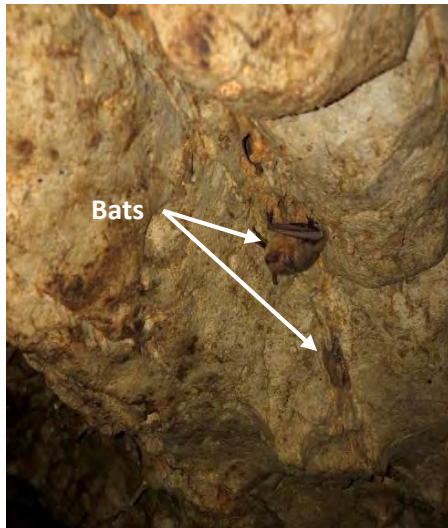
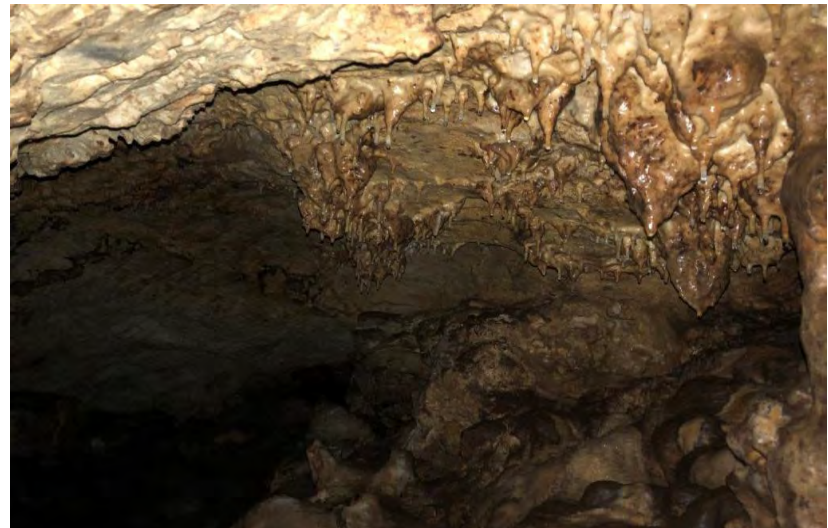
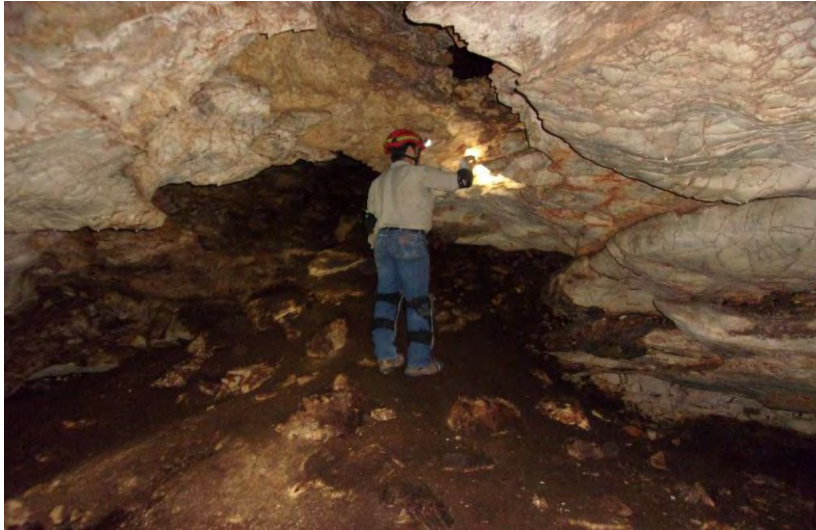
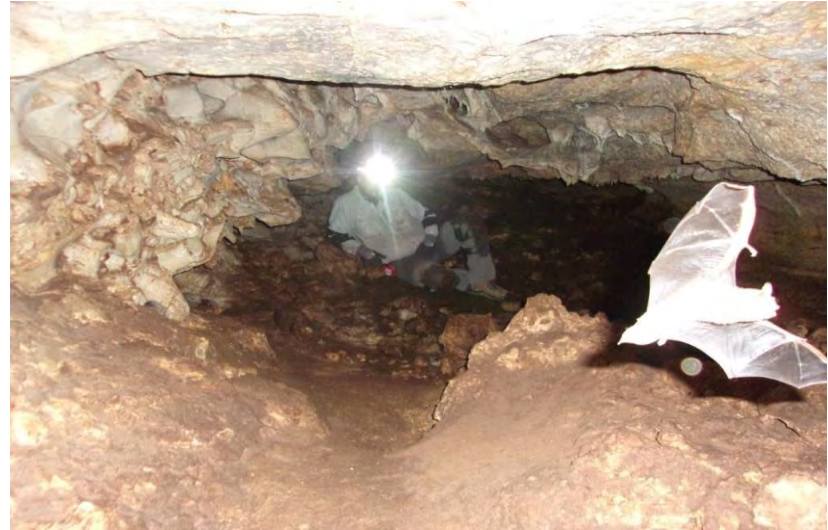
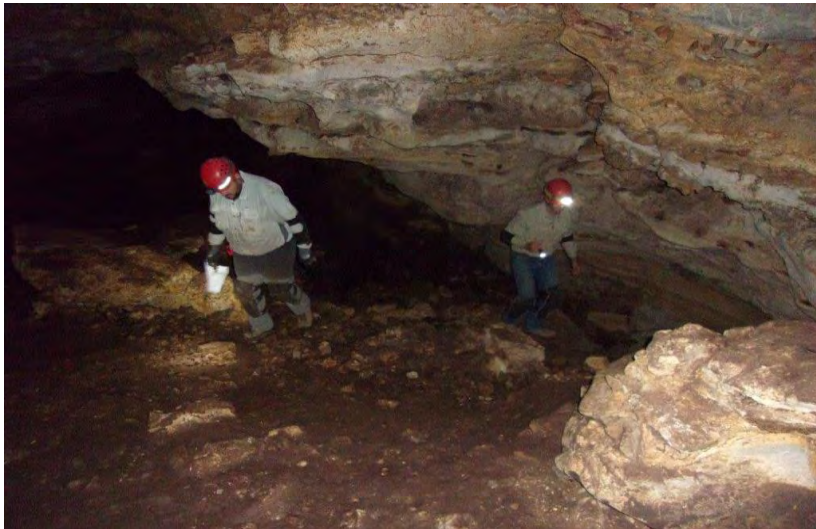
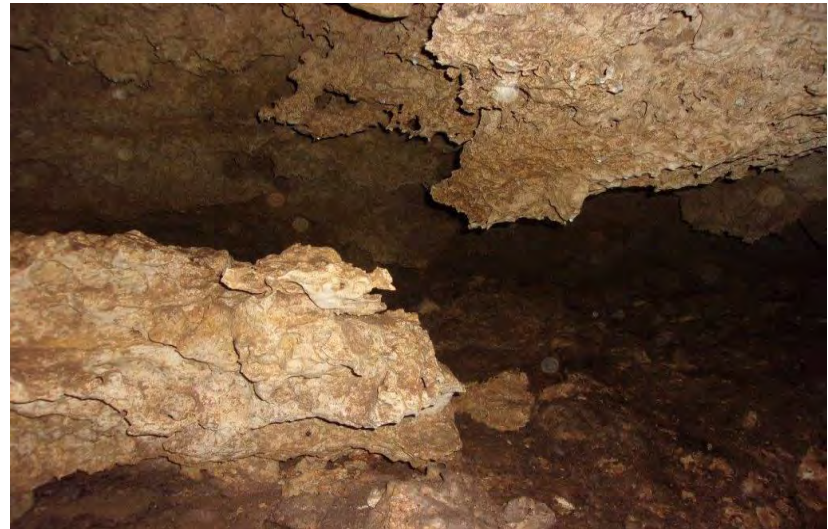
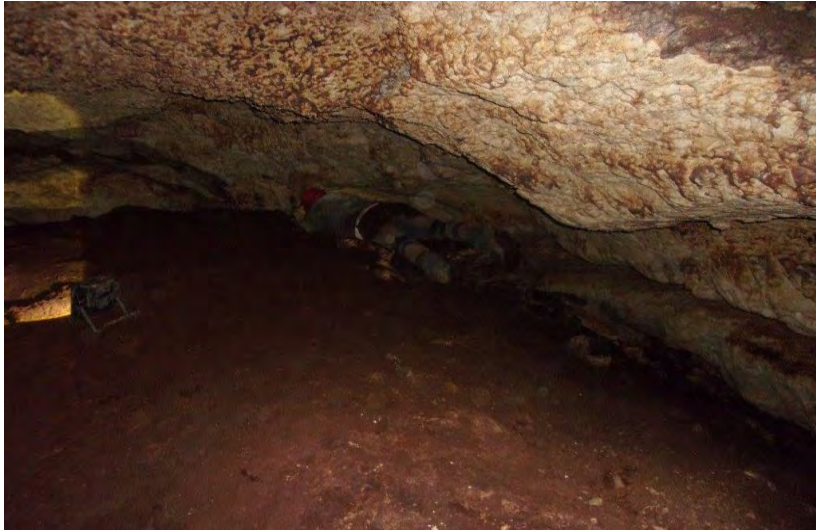
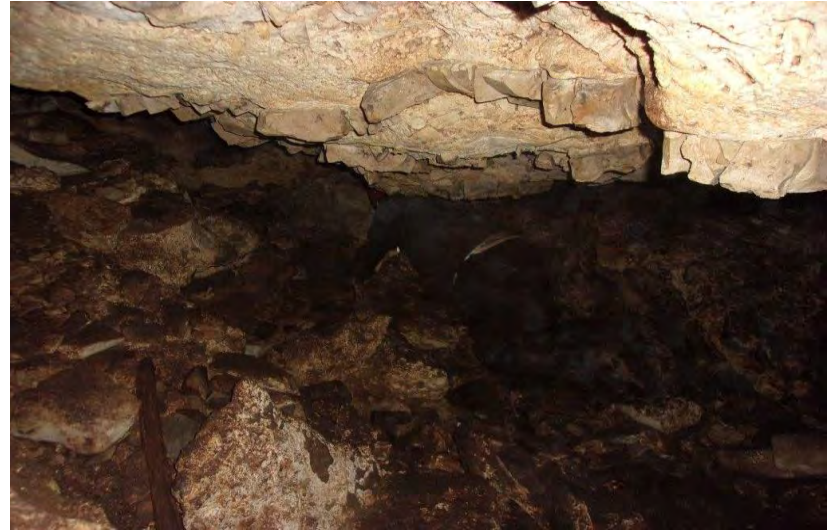
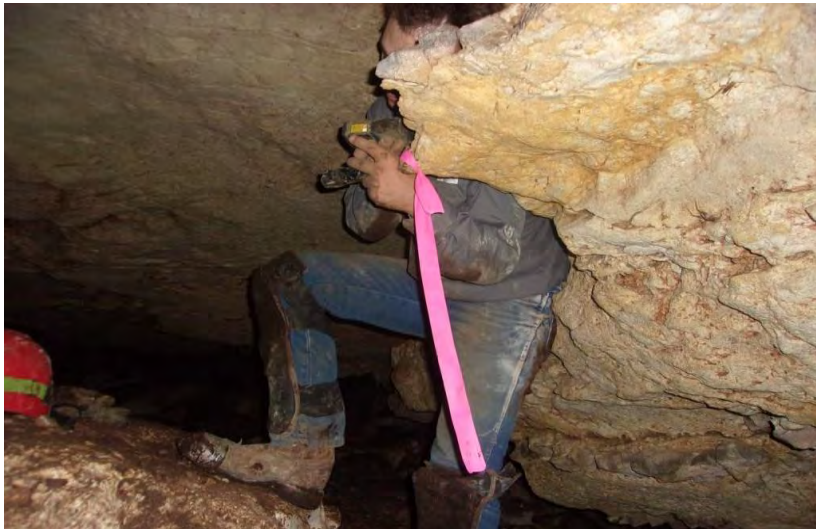
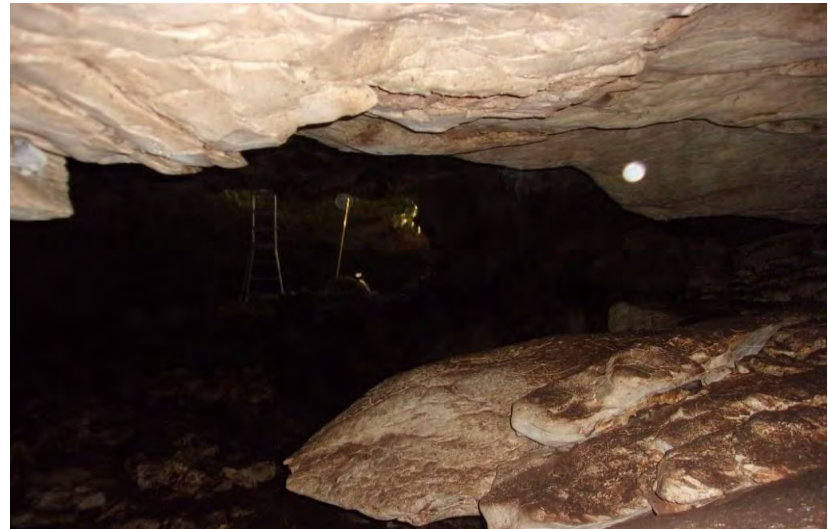
Feature S-2 consists of a large sinkhole feature with extensive cave development that appears to have been well known and explored historically. The cave was most recently mapped by the Texas Speleological Society (TSS) in 1995 and designated as the Coreth Cave. The cave is also referred to as the R. R. Coreth Caverns and/or Corith Caves in *A Revised Checklist of Texas Caves prepared by the Texas Speleological Association (1966)*. The surface collapse feature and associated subsurface cave extent measures approximately 230 x 130 x 69 feet in length, width, and depth, respectively. The cave is formed completely within the upper part of the Person Formation and oriented along the dominant NE-SW structural trend, although no well-defined fractures were observed within the cave. The cave appears to have been formed by collapse associated with the surrounding sinkhole and the entrance consists of a vertical shaft that extends on the order of 15 feet to the cave floor and facilitates access to the cave by a small bat population.

- From the primary entrance, the cave opens into a large and laterally extensive room measuring approximately 70 x 50 x 8 feet in length, width, and height respectively. The room trends to the east and connects to a primary passageway that roughly defines the lateral extent of the cave in the subsurface. The passageway is estimated to comprise more than 420 linear feet and becomes narrower with distance into the cave. Several small rooms and parallel chambers were observed along the primary passageway. The passageway slopes downward as it extends from the entrance, reaching a maximum estimated depth of about 69 feet relative to surrounding ground surface.

- The cave ceiling and upper portion of the room consists of gray honeycombed limestone. Moving downward into the cave, the walls and ceiling areas unaffected by secondary mineral growth are white to buff massive limestone with interbedded chert nodules. It appears that most of the cave formation was within this lower rock unit and in similar bedding units at deeper levels within the cave. As the cave has been enlarged by the periodic collapse of ceiling units in conjunction with limestone dissolution, several feet collapse materials cover the cave floor and no clear exposures of limestone were observed along the cave bottom throughout its accessible extent.

- The cave is host to a significant biologic population including bats. The cave floors within the majority of the rooms and passageways is covered with several feet to a veneer of bat guano in various stages of decomposition. Thriving insect populations that feed on the guano were observed including crickets and spiders of various types. Based on the guano accumulations, it appears that the cave has been inhabited by bats for many decades. At the time survey activities were conducted, a small bat population was present. The large room at the cave entrance also appears to periodically host small animals including snakes, skunks, and raccoons.

- Survey activities were conducted during dry weather conditions and cave conditions were generally moist with the exception of the rooms and passages throughout the lowermost cave levels, which exhibited water drips and drops on stalactites. General observations throughout the cave including the presence of speleothems and flow stone surfaces indicate the periodic migration of water to the subsurface.

This feature is classified as sensitive owing to rapid infiltration potential.

Feature S-2 consists of a large sinkhole feature with extensive cave development that appears to have been well known and explored historically. The cave was most recently mapped by the Texas Speleological Society (TSS) in 1995 and designated as the Coreth Cave and has also been referred to as the R. R. Coreth Caverns and/or Corith Caves. The surface collapse feature and subsurface cave extent measures approximately 230 x 130 x 69 feet in length, width, and depth, respectively. The cave entrance consists of a vertical shaft that extends on the order of 15 feet to the cave floor and facilitates access to the cave by a small bat population. From the primary entrance, the cave opens into a large and laterally extensive room measuring approximately 70 x 50 x 8 feet in length, width, and height respectively. The room trends to the east and connects to a primary passageway that roughly defines the lateral extent of the cave in the subsurface. The passageway is estimated to comprise more than 420 linear feet and becomes narrower with distance into the cave. Several small rooms and parallel chambers were observed along the primary passageway. The passageway slopes downward as it extends from the entrance, reaching a maximum estimated depth of about 69 feet relative to surrounding ground surface.

At the time survey activities were conducted, a small bat population was present. Based on the guano accumulations (i.e., 2 feet to veneer), it appears that the cave has been inhabited by bats for many decades. Thriving insect populations that feed on the guano were observed including crickets and spiders of various types. The large room at the cave entrance also appears to periodically host small animals including snakes, skunks, and raccoons.

Survey activities were conducted during dry weather conditions and cave conditions were generally moist with the exception of the rooms and passages throughout the lowermost cave levels, which exhibited water drips and drops on stalactites. General observations throughout the cave including the presence of speleothems and flow stone surfaces indicate the periodic migration of water to the subsurface.

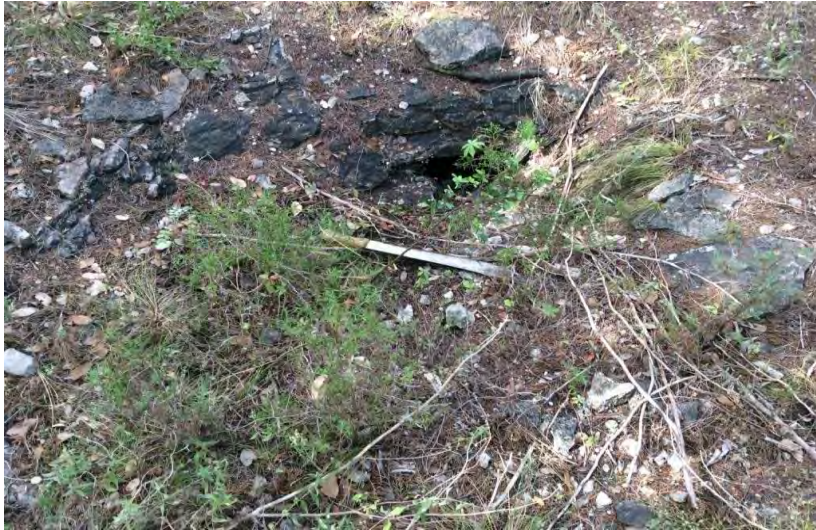
Photo 33 – Feature S-3.

Feature S-3 consists of a solution cavity within a small depression that is completely rimmed and floored by intact limestone. The feature was apparently formed as the result of surface erosional processes. The depression measures approximately 7 x 6 x 2.5 feet in length, width, and depth respectively. The feature is located within the Person Formation on the hilltop near the north portion of the property. The solution cavity opening measures approximately 1.3 x 0.7 feet in length and width, respectively. Based on hand-excavation activities and probing, the feature is infilled with clay soils and some organic materials and is sometime host to burrowing animals. There was no channeling or preferential flow directed to this feature. See Photo #33 in the attached **Feature Photograph Log**.

Feature S-3 consists of a solution cavity within a small depression that is completely rimmed and floored by intact limestone. The feature was apparently formed as the result of surface erosional processes. The depression measures approximately 7 x 6 x 2.5 feet in length, width, and depth respectively. The feature is located within the Person Formation on the hilltop near the north portion of the property. The solution cavity opening measures approximately 1.3 x 0.7 feet in length and width, respectively. Based on hand-excavation activities and probing, the feature is infilled with clay soils and some organic materials and is sometime host to burrowing animals. There was no channeling or preferential flow directed to this feature.

This feature is classified as not sensitive, having a low potential of transmitting fluids into the Edwards. This classification is based upon its stratigraphic position, point assignment criteria presented in the Geologic Assessment Table (TCEQ-0585), and professional judgment.

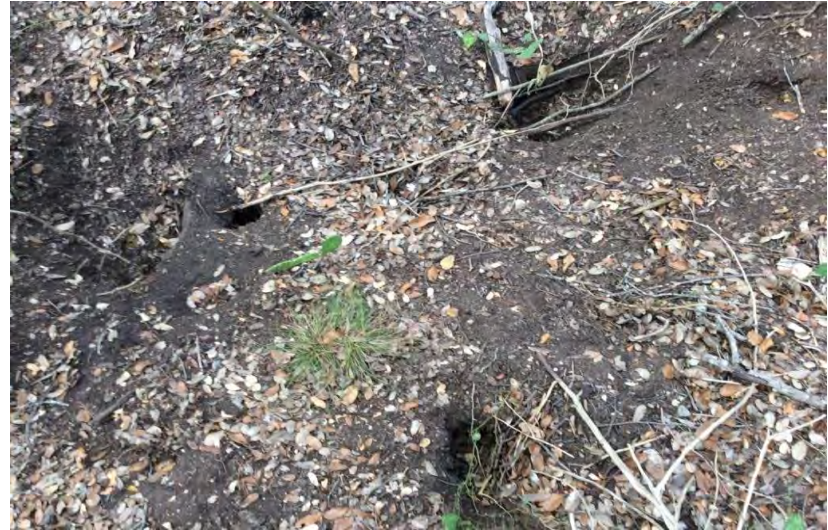
Photo 34 – Feature S-4.

Feature S-4 consists of a non-karst closed depression formed by a tree root collapse along the base of a large Oak tree, which has been enhanced by animal burrowing. The feature is located within the north portion of the of the property. The feature dimensions are on the order of 8 x 5 x 2.5 feet in length, width, and height, respectively. The feature is completely contained within dark reddish-brown clay soil and with no connection to underlying limestone bedrock. There was no channeling or preferential flow directed to this feature. See Photo #34 in the attached **Feature Photograph Log**.

Feature S-4 consists of a non-karst closed depression located in the north portion of the property. The feature measures approximately 8 x 5 x 2.5 feet, in length, width, and height, respectively.

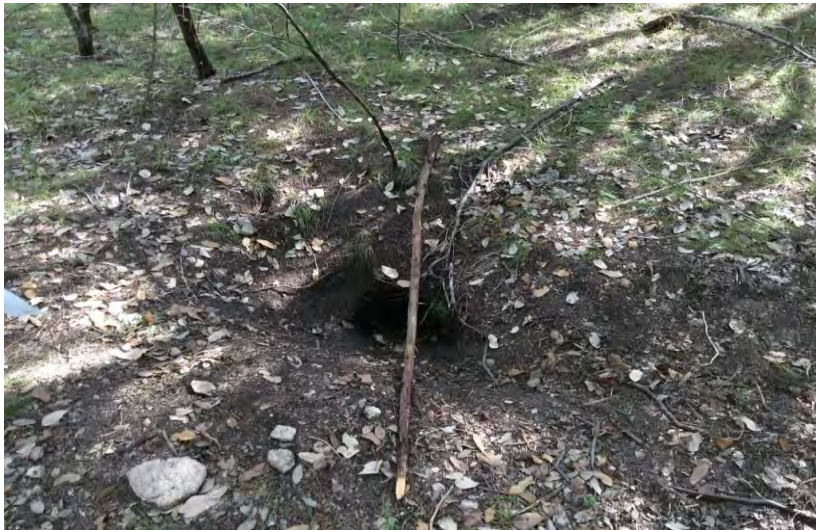
Photo 35 – Feature S-5.

Feature S-5 consists of a non-karst closed depression formed by a historical tree root collapse and enhanced by burrowing animals. The feature is located on the hillside within the west portion of the of the property. The feature dimensions are on the order of 6 x 4 x 2 feet in length, width, and height, respectively. The feature is completely contained within dark reddish-brown clay soil and with no connection to underlying limestone bedrock. There was no channeling or preferential flow directed to this feature. See Photo #35 in the attached **Feature Photograph Log**.

Feature S-5 consists of a non-karst closed depression located on the hillside within the west portion of the property. The feature measures approximately 6 x 4 x 2 feet, in length, width, and height, respectively.

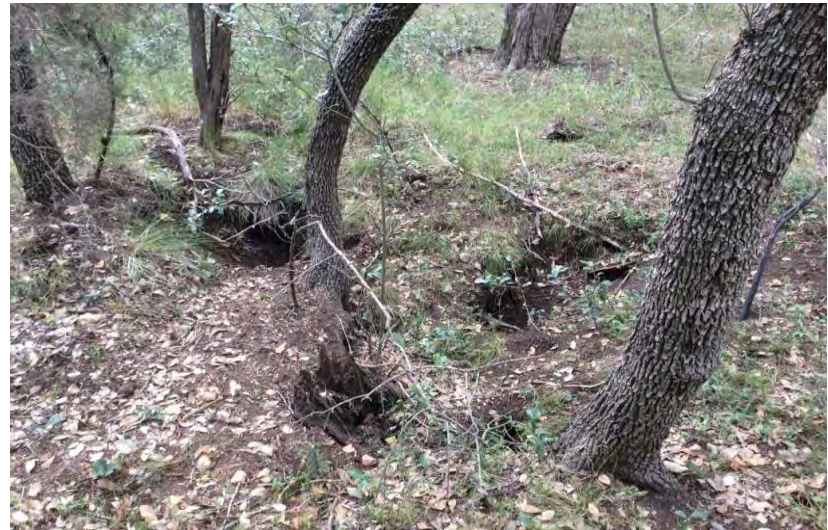
Photo 36 – Feature S-6.

Feature S-6 consists of a non-karst closed depression formed by tree root collapse. The feature is further enhanced in multiple locations by burrowing animals. The feature is located on the hillside within the west portion of the of the property, approximately 135 feet west of **Feature S-5**. The feature dimensions are on the order of 8 x 6 x 3 feet in length, width, and height, respectively. The feature is completely contained within dark reddish-brown clay soil and with no connection to underlying limestone bedrock. There was no channeling or preferential flow directed to this feature. See Photo #36 in the attached **Feature Photograph Log**.

Feature S-6 consists of a non-karst closed depression located on the hillside within the west portion of the property, approximately 135 feet west of **Feature S-5**. The feature, measures approximately 8 x 6 x 3 feet, in length, width, and height, respectively.

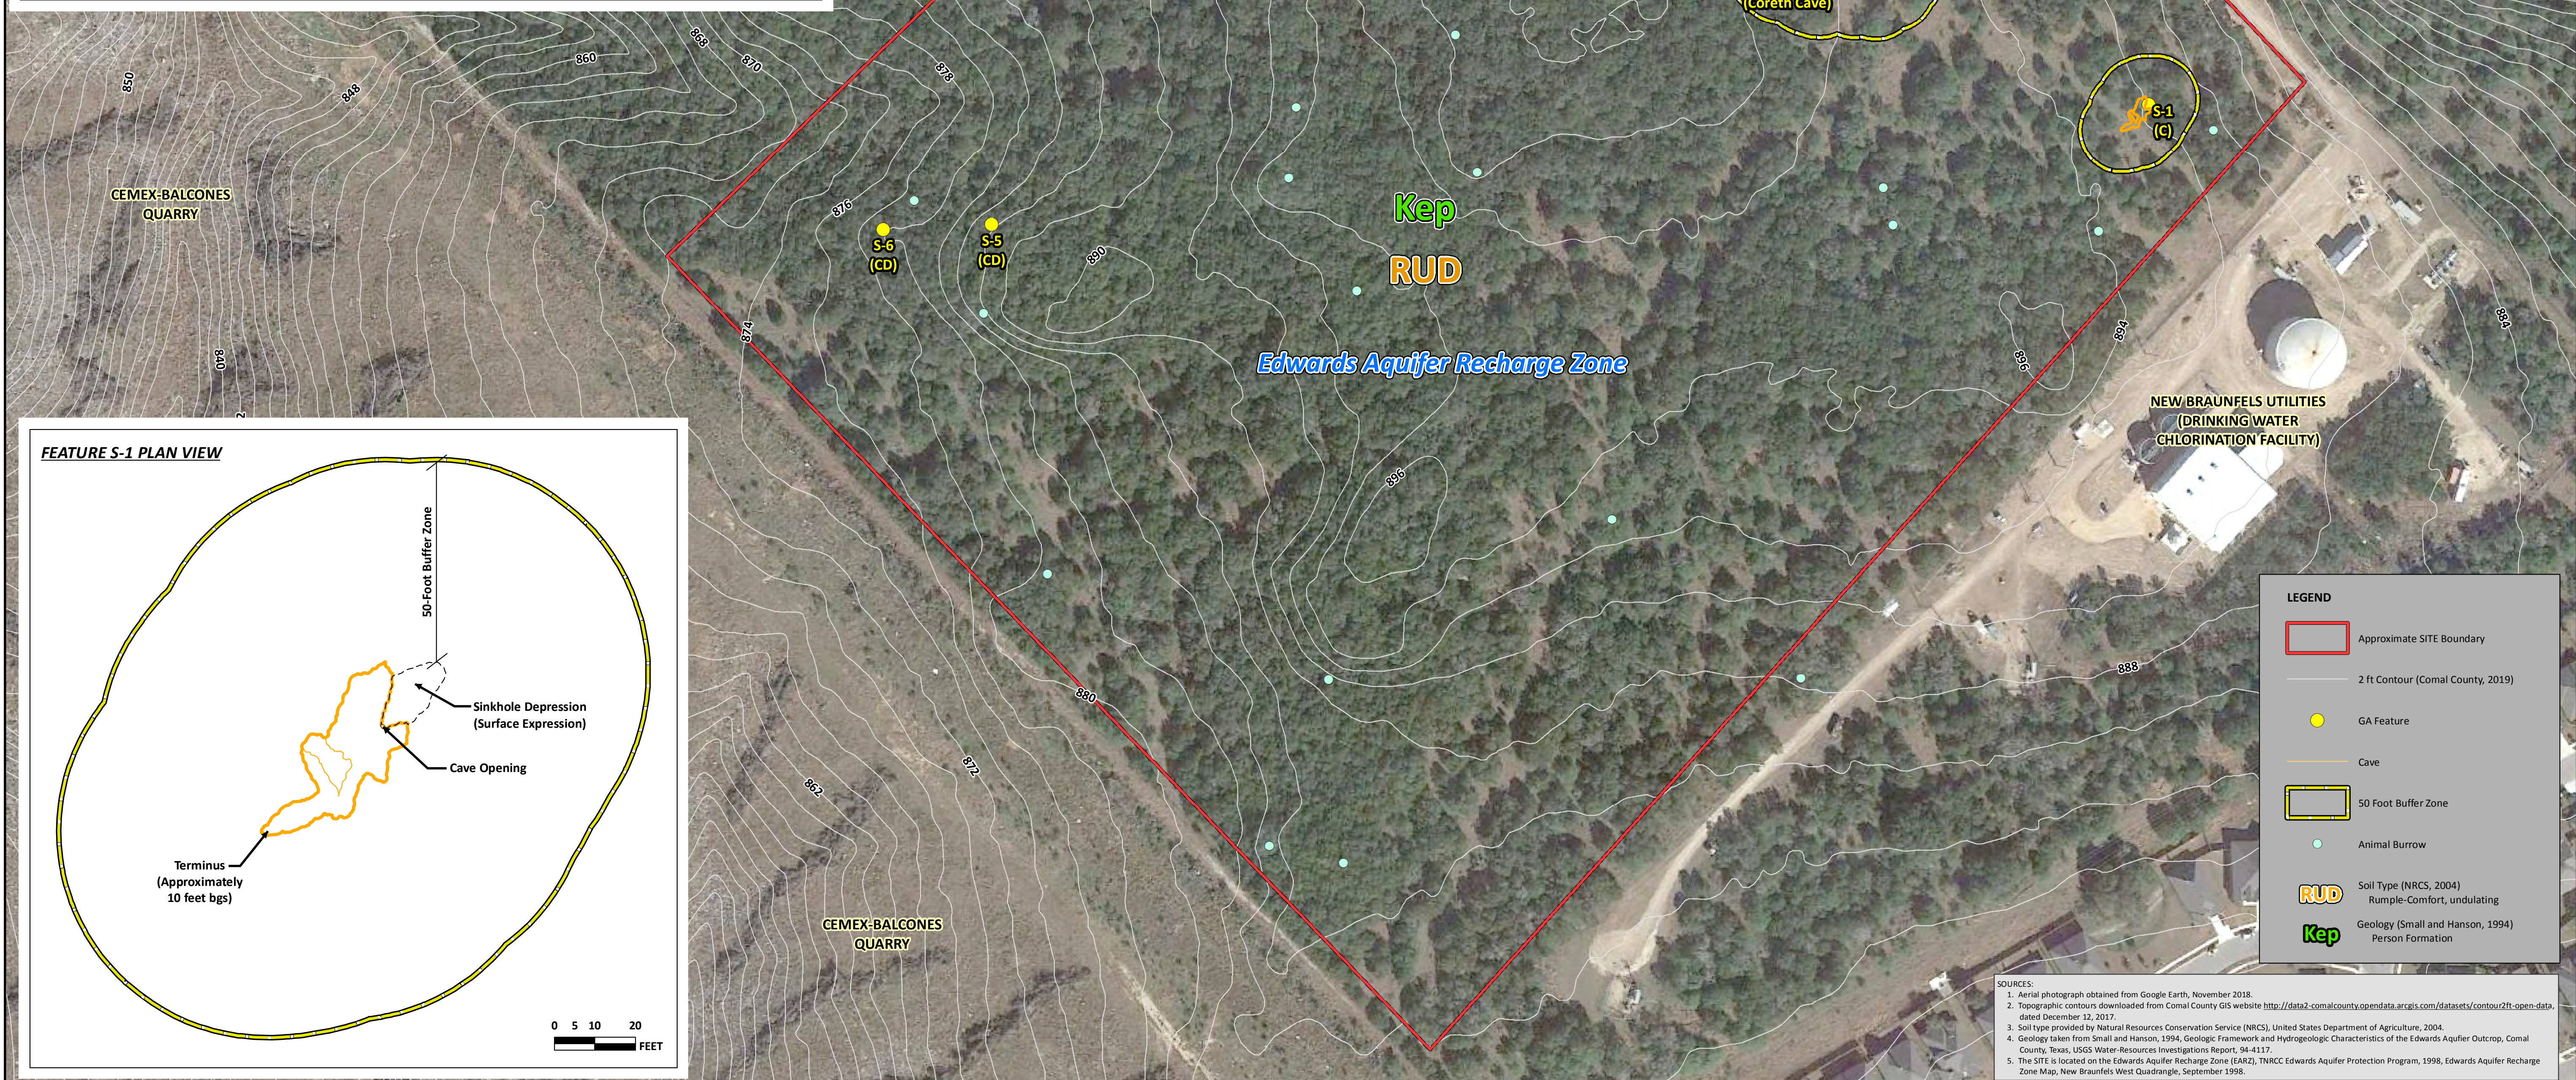
FEATURE S-2 PLAN VIEW
(CORETH CAVE)

This map illustrates the layout of Coreth Cave, showing the cave entrance (vertical shaft) and the approximate location of the sinkhole depression (surface expression). The cave entrance is located near the bottom left, and the sinkhole depression is located near the top left. The cave is divided into three rooms: Primary Room #1, Room #2, and Room #3. A winding passageway connects the rooms. A 50-foot buffer zone is indicated around the cave entrance. The map also shows a dashed line representing the boundary of the sinkhole depression, which is approximately 69 feet by 69 feet. A scale bar at the bottom right indicates distances in feet (0, 10, 20, 40).
